*Sewer Optics*  
Property Inspection Report

# Sewer Camera Inspection Comments

## 1. Conditions of Sewer Line

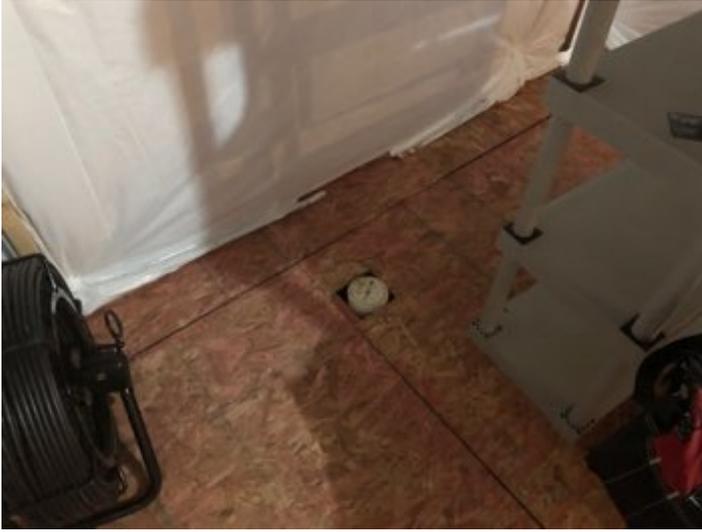
Pre inspection work area

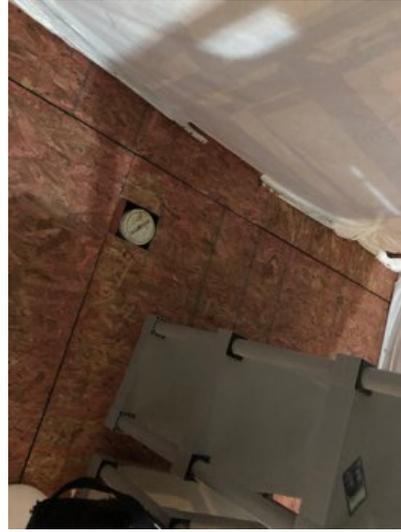
Post inspection work area
